### Retailer Bulletin

#### E-Caliber pedal-assist issue

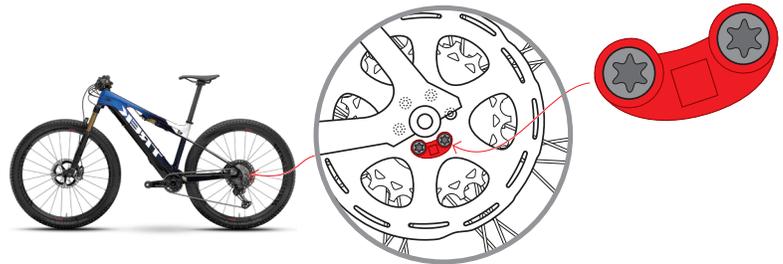
The speed sensor can count double or triple the revolutions of the back wheel. The magnetic field can come too close to the speed sensor and the Fazua system is not able to filter out the error.

1. Remove the magnet.
