Specialized Turbo Levo Motor housing Water and Silt issue.

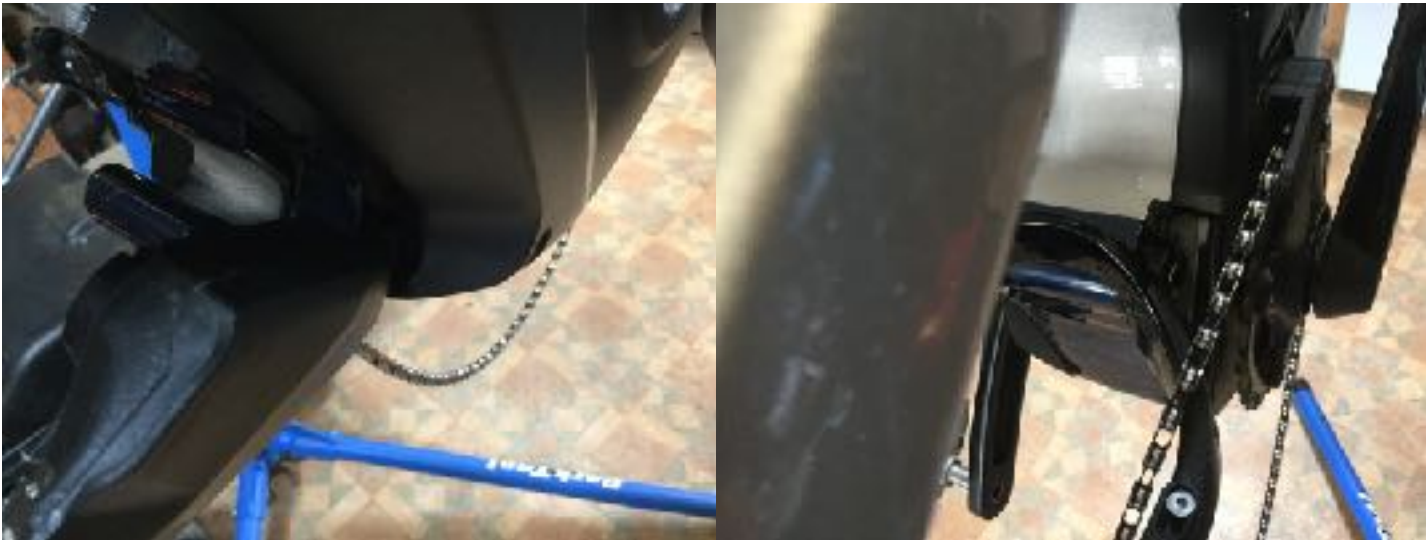
Semi open design allows water to enter at the battery lead aperture and in particular at the back of the motor where water and mud from the wheel is directed at the exposed motor.

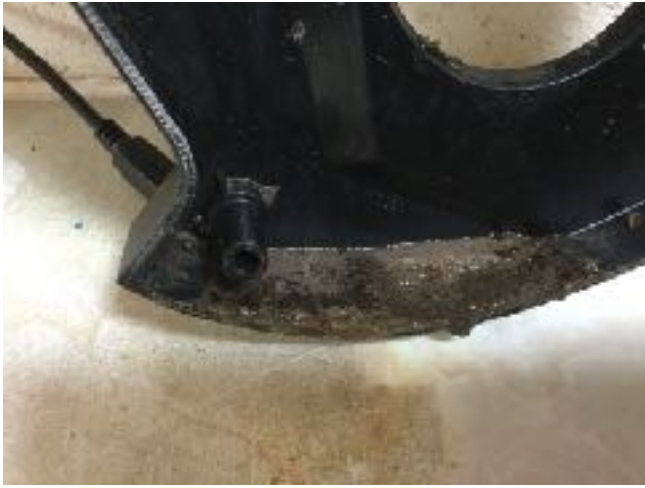
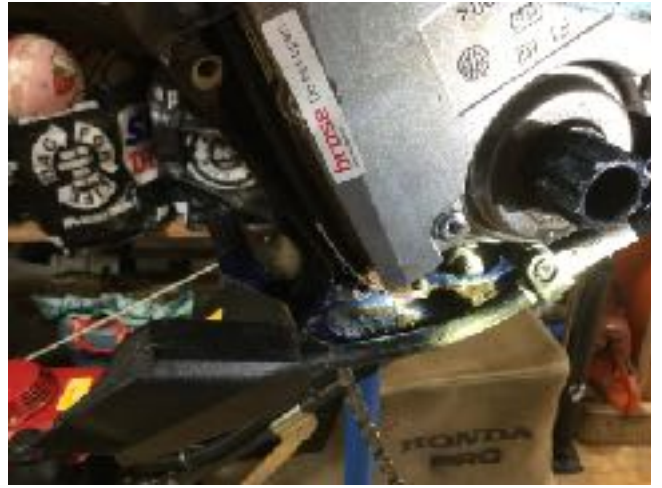
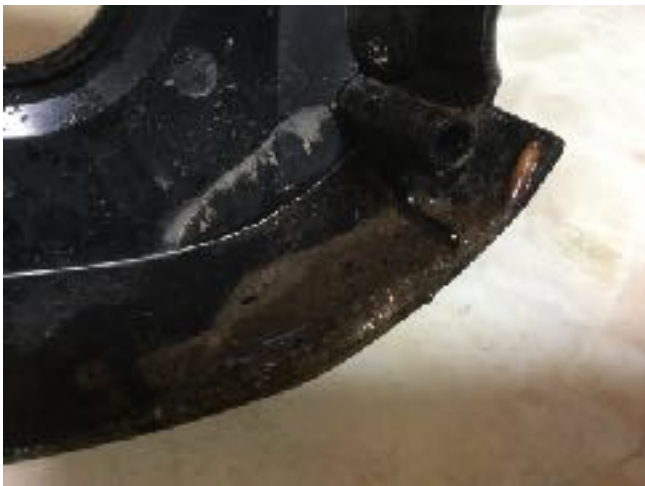
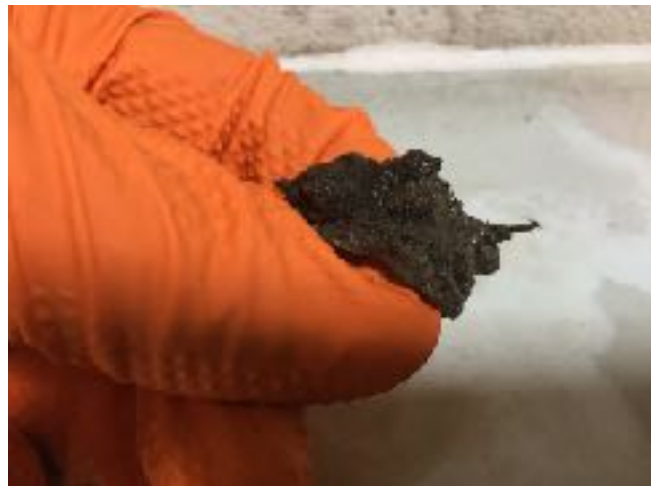
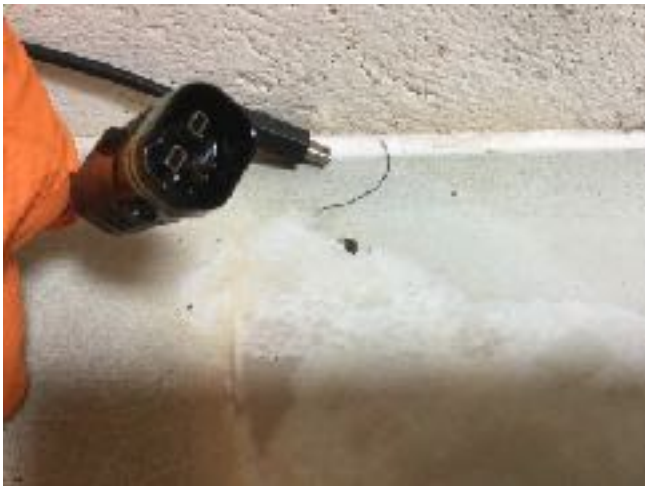
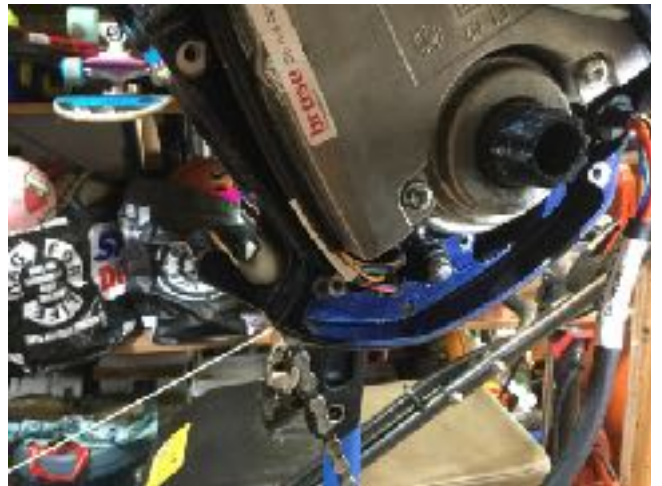
Despite the waterproof nature of the electrical connectors moisture ingress was observed after a very short period of time. A further issue would be the patchy quality control at manufacture as 2 of the 3 electrical connectors did not have complete or in one case any O ring gaskets which give the plugs their IP rating.

Above: Photos showing silt build up, also moisture ingress in the main battery to motor plug and drain hole still blocked even after cleaning.

Firstly all o rings need to be present, second a smear of suitable grease to help seal the connectors and finally as recommended by UK Specialised rider care a corrosion block to the terminals themselves, I understand this is becoming a standard service procedure.

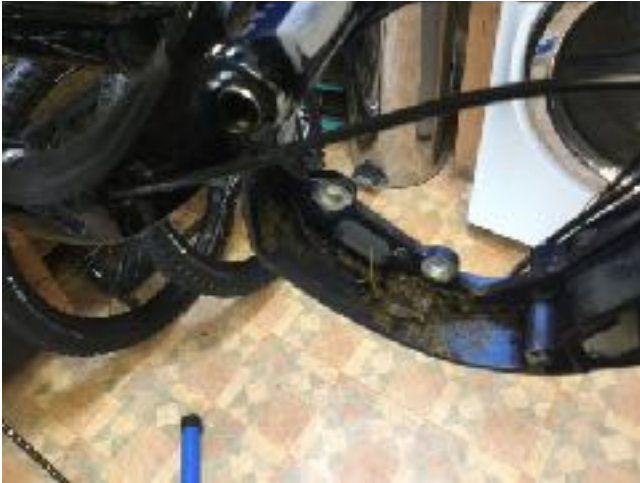
Above: Motor removed shows the extent of the silt build up and drainage problems.

As for the motor housing itself it would appear due to the design virtually impossible to stop water entry so the answer seems to be to improve drainage to let water and silt out. Two 7mm drain holes one in each of the lower plastic housings let the water and silt straight out. there is a slight downside in that cycling with the motor submerged may allow more water in, hopefully the additional waterproofing of the electrical connectors should negate this.

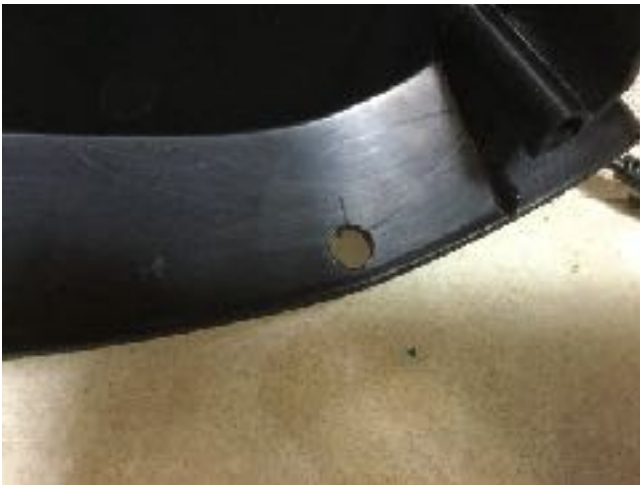
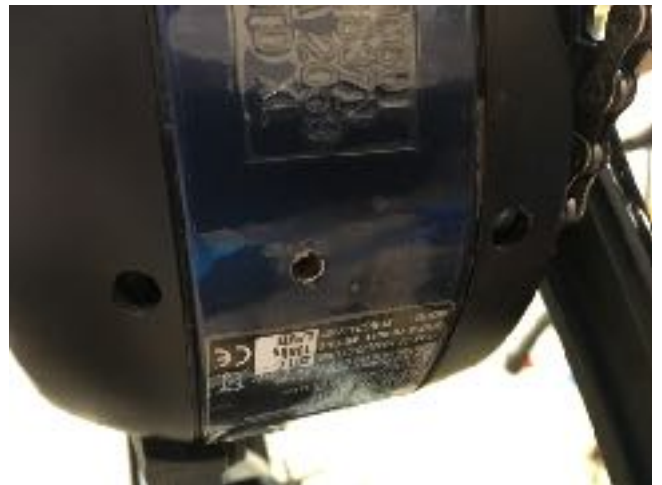
Above: Additional holes drilled a the plastic housing low points to assist drainage.

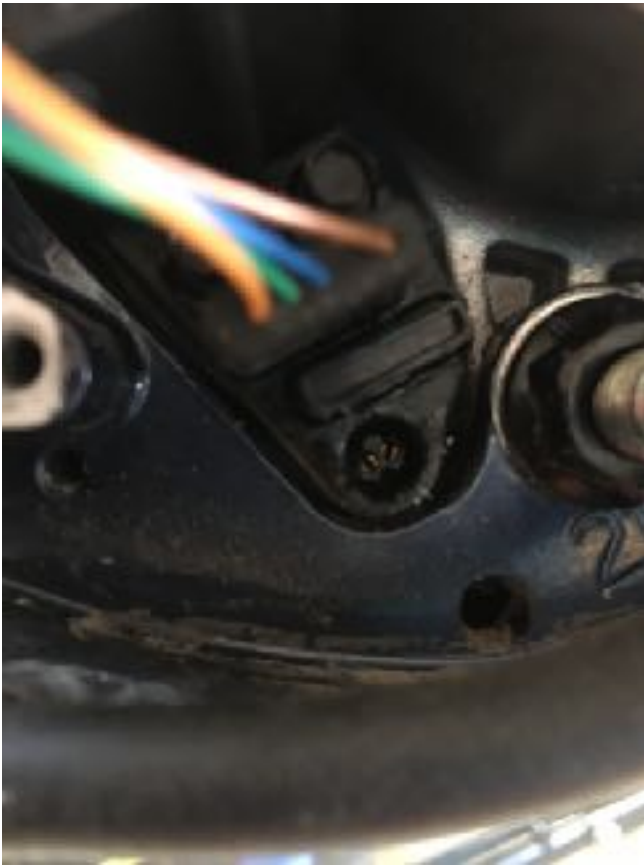
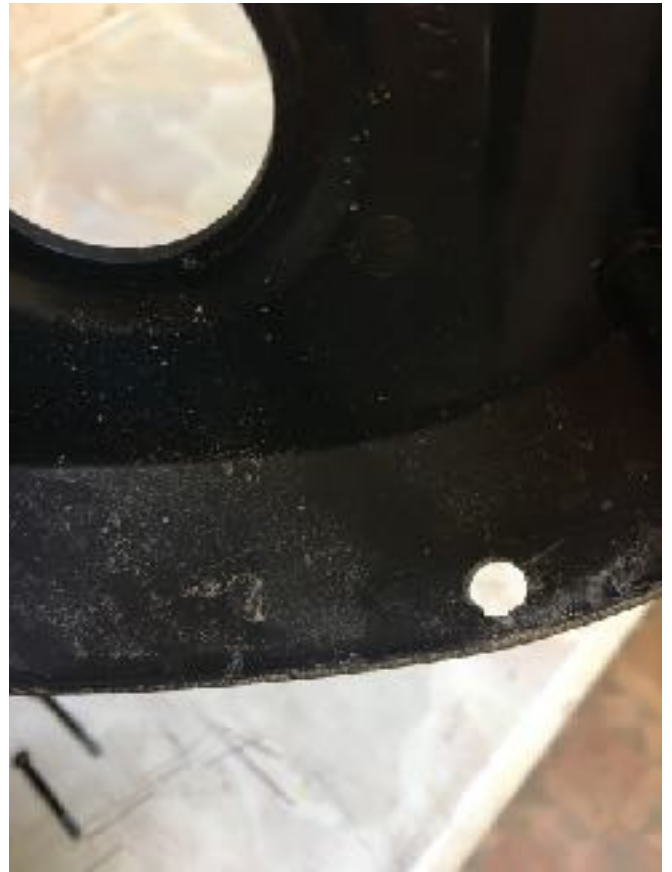
Motor cover removed after new drain holes added and ridden in similar conditions as before.

After riding in similar conditions and then removing the motor cover the new drain holes would appear to be working. Some silt residue is visible but there is no remaining moisture and the electrical connectors are dry and sound, even the ones with missing o rings.
