TECHNICAL SERVICE BULLETIN #156.2

e*spec Shimano™ alloy crank tech update

Product(s) included: e*thirteen e*spec Shimano EP8 / E8000 alloy cranks.

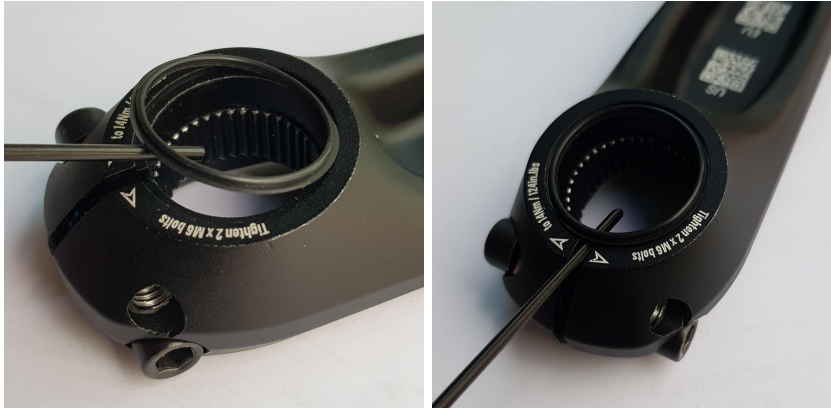
We have had reports of crank arm preload caps from affected cranks loosening up and falling off. If crank pinch bolts, which fix the arm to the axle, are not tightened to spec or properly tightened, it is possible that lack of cap and incorrect installation torque and/or install technique could lead to the arm loosening.

- Torque specification updates:
 - Original torque specification: Preload cap: 1Nm / Pinch bolts: 12-14Nm.*
 - Updated torque spec: Preload cap 2Nm / Pinch bolts: 14Nm.***Correct tightening procedure is critical. Please reference directions below*
- Inner seal removal:
 - The seal found at the inner face of the crank should be removed from the assembly. This avoids potential false torque readings and provides an additional 1mm of interface between the crank and spindle.
