DOES IT WORK?

MudStop is a bearing protection cover to help prolong the main motor bearing life for Bosch Performance Line and Performance Line CX motors.

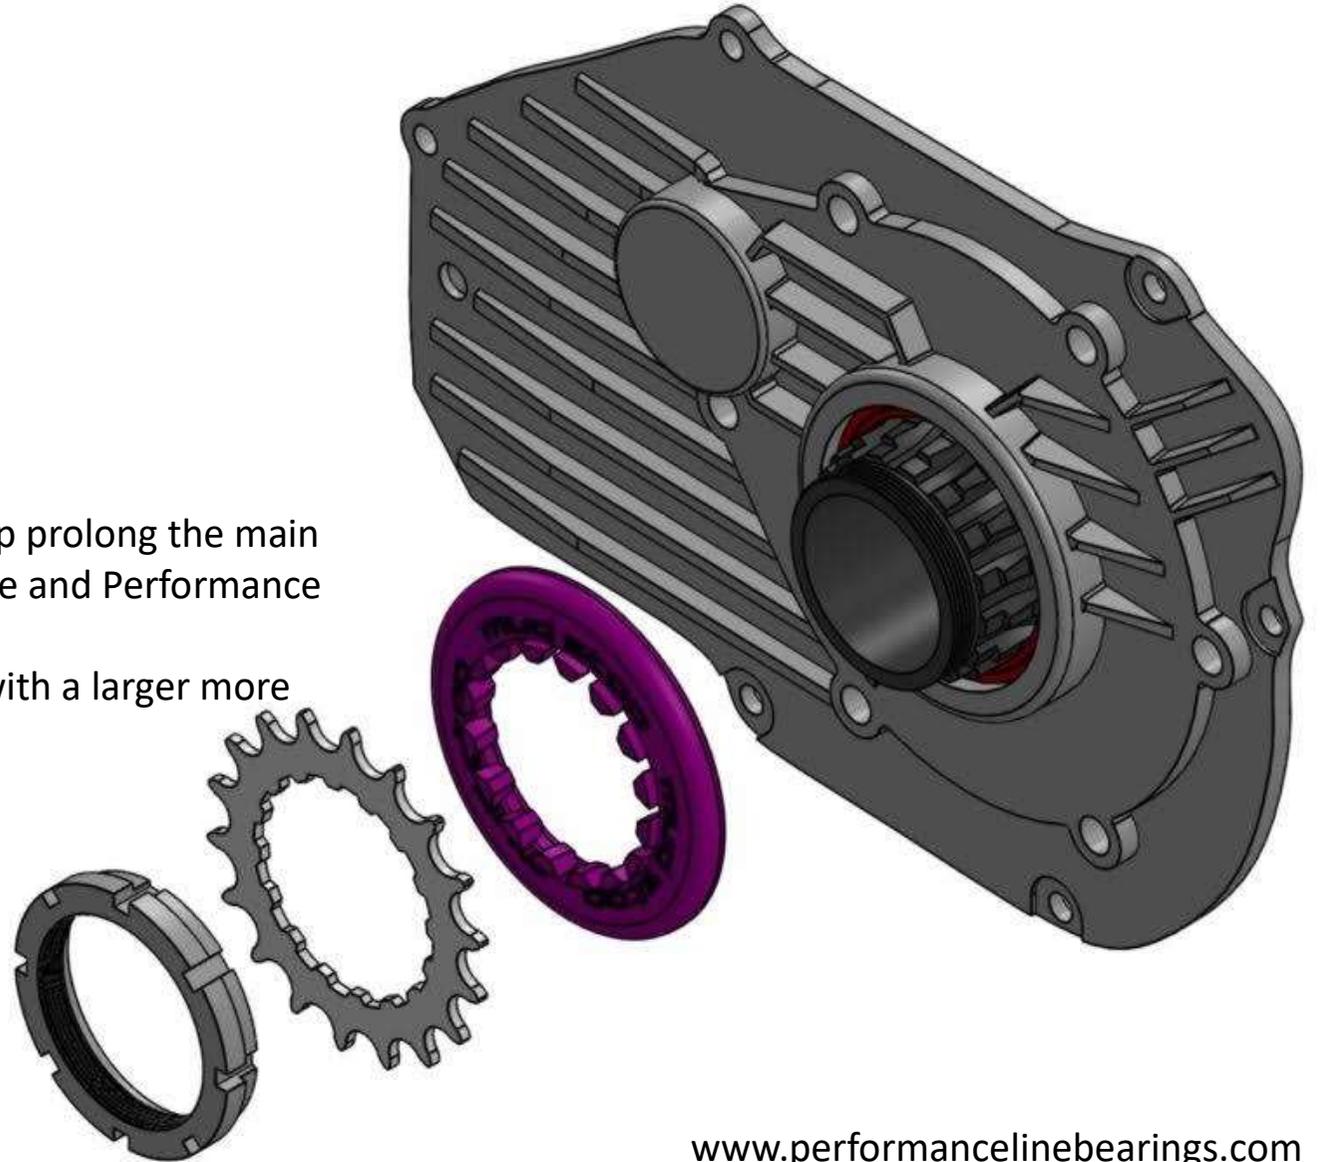
First we should look at a Bosch bearing cover. Definitely better than nothing but has its limitations.

The Bosch bearing cover sits on top of the bearing and has a moving joint between the bearing cover and the motor cover.

This gap is not waterproof and any grit or dirt sticking to the grease eventually gets wound into the bearing.

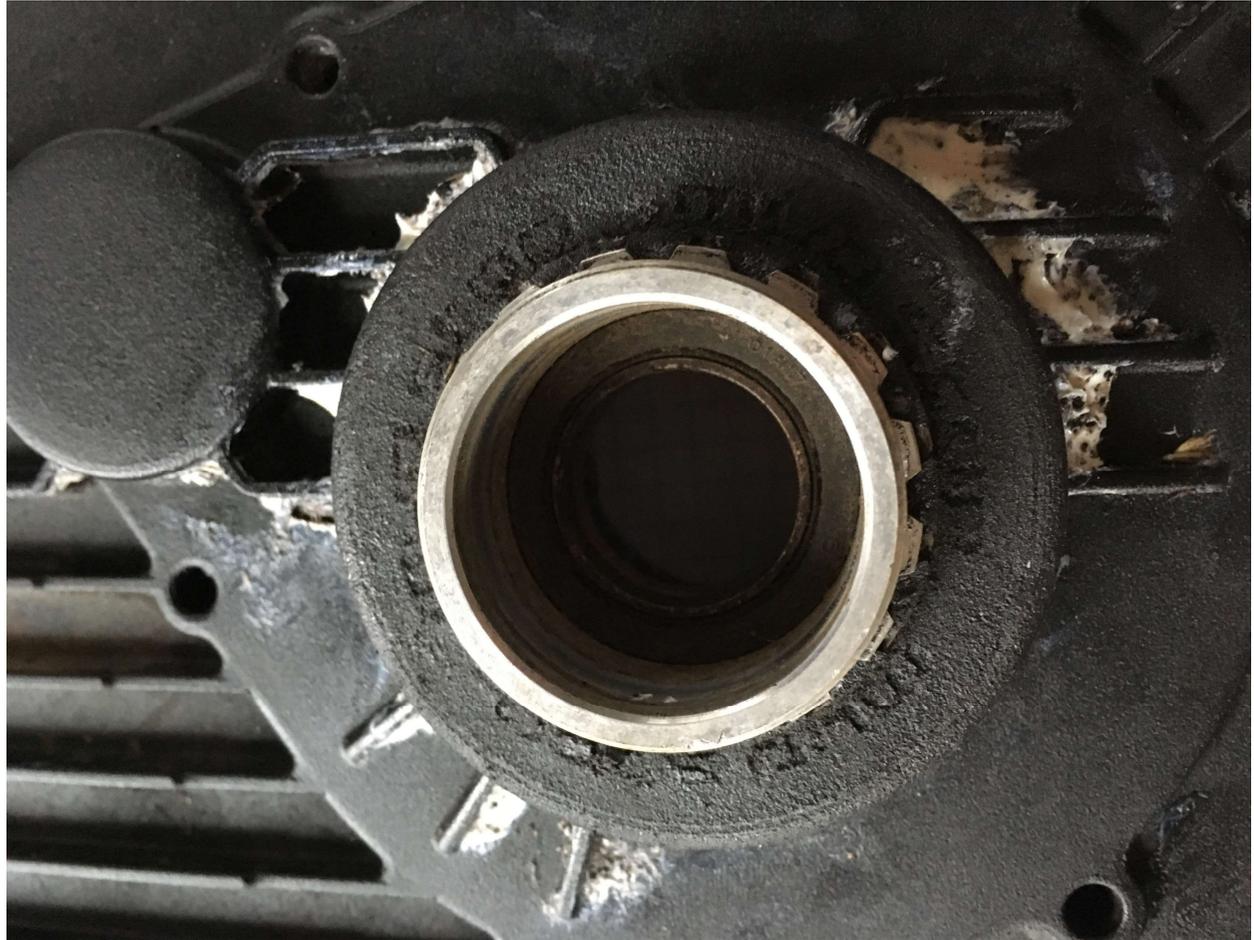
The MudStop on the right has been fitted for a year and travelled 2,732 Miles (4.397 Km)

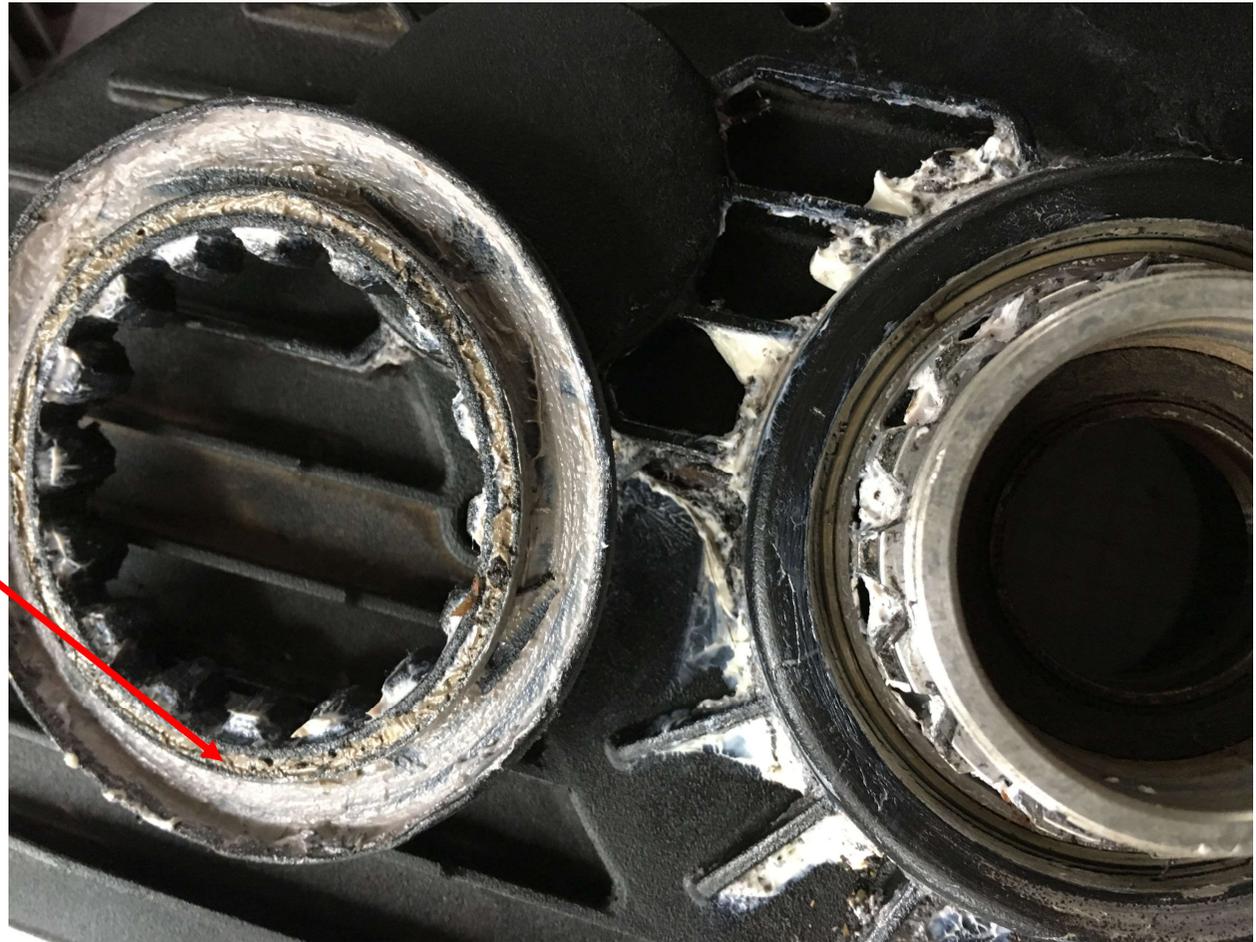
Removing the MudStop we can see that even though the wrong grease was used, it really has done a good job of stopping any mud, grit, dirt or water getting to the vulnerable bearing.

We can see that most of the dirt has been caught in the groove that sits atop of the bearing. (this grit catching groove is missing on the Bosch seal)

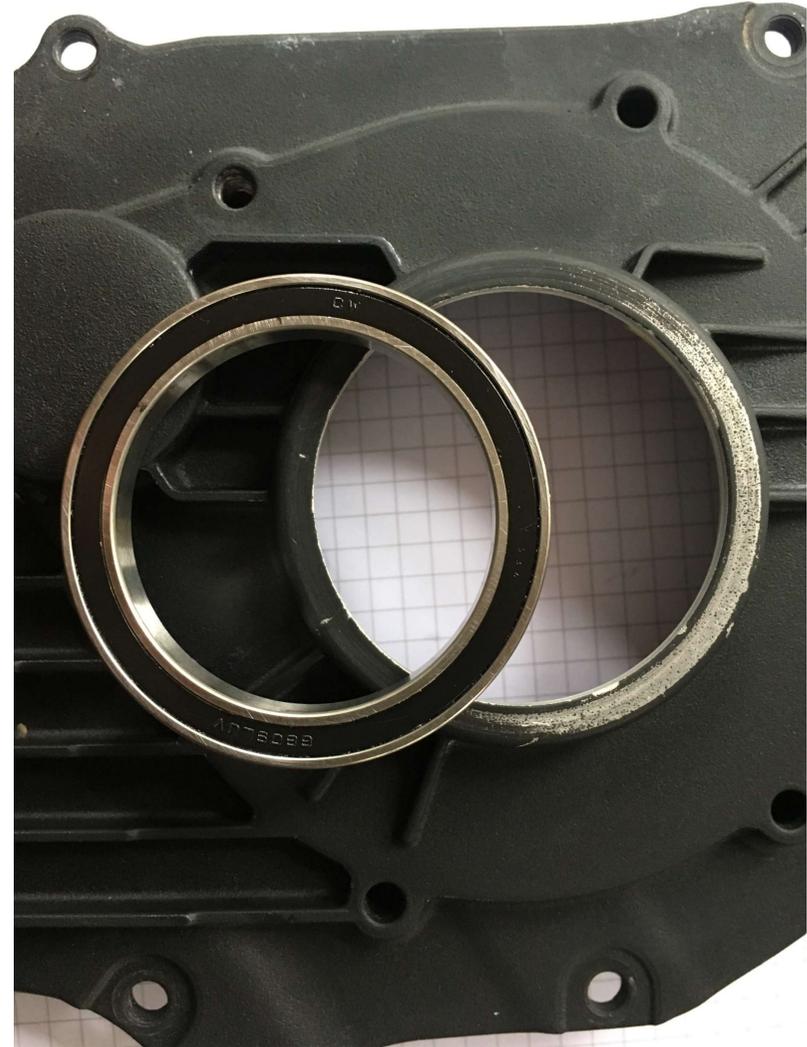
With everything cleaned up we can see exactly what's been going on.

The main motor bearing was in perfect condition although just the top surface of paint has been removed from one side of the casing (This may have been due to the grease as the next example will show).

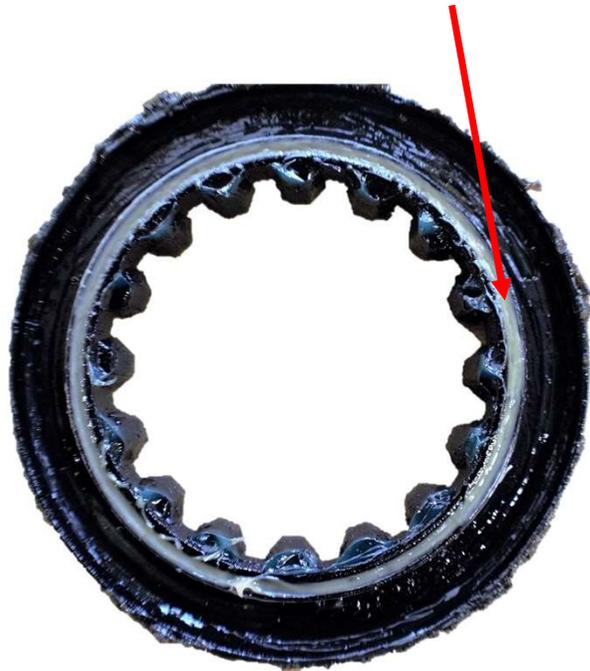
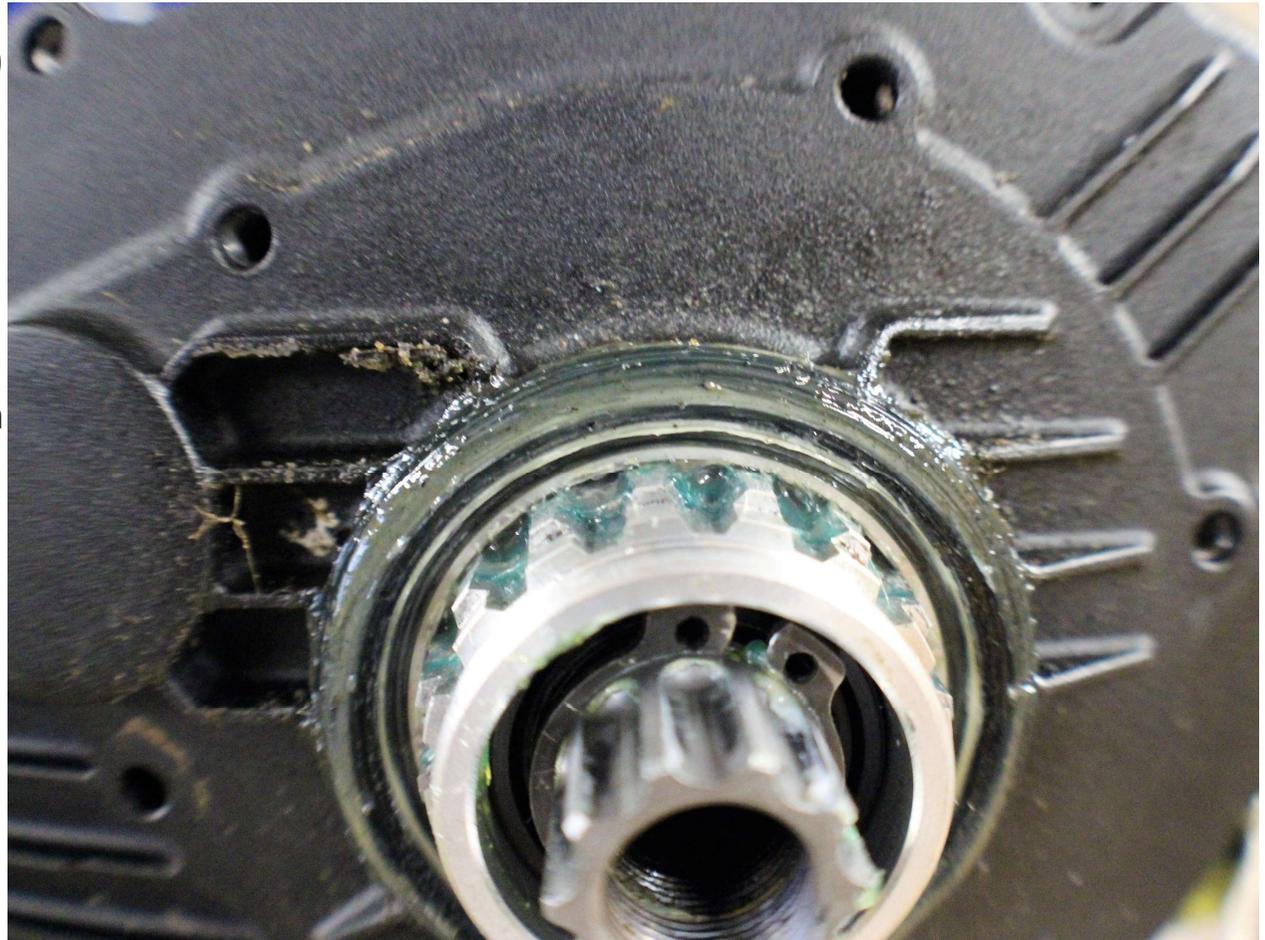
This motor had only covered 600 Miles (966 Km)
But, it went through one of England's wettest
winters on record. It's fitted to an MTB and only
used off road.

The motor has also been regularly washed.

The colour of the grease shows it has started to
emulsify with the water, but again, this has been
caught in the bearing groove

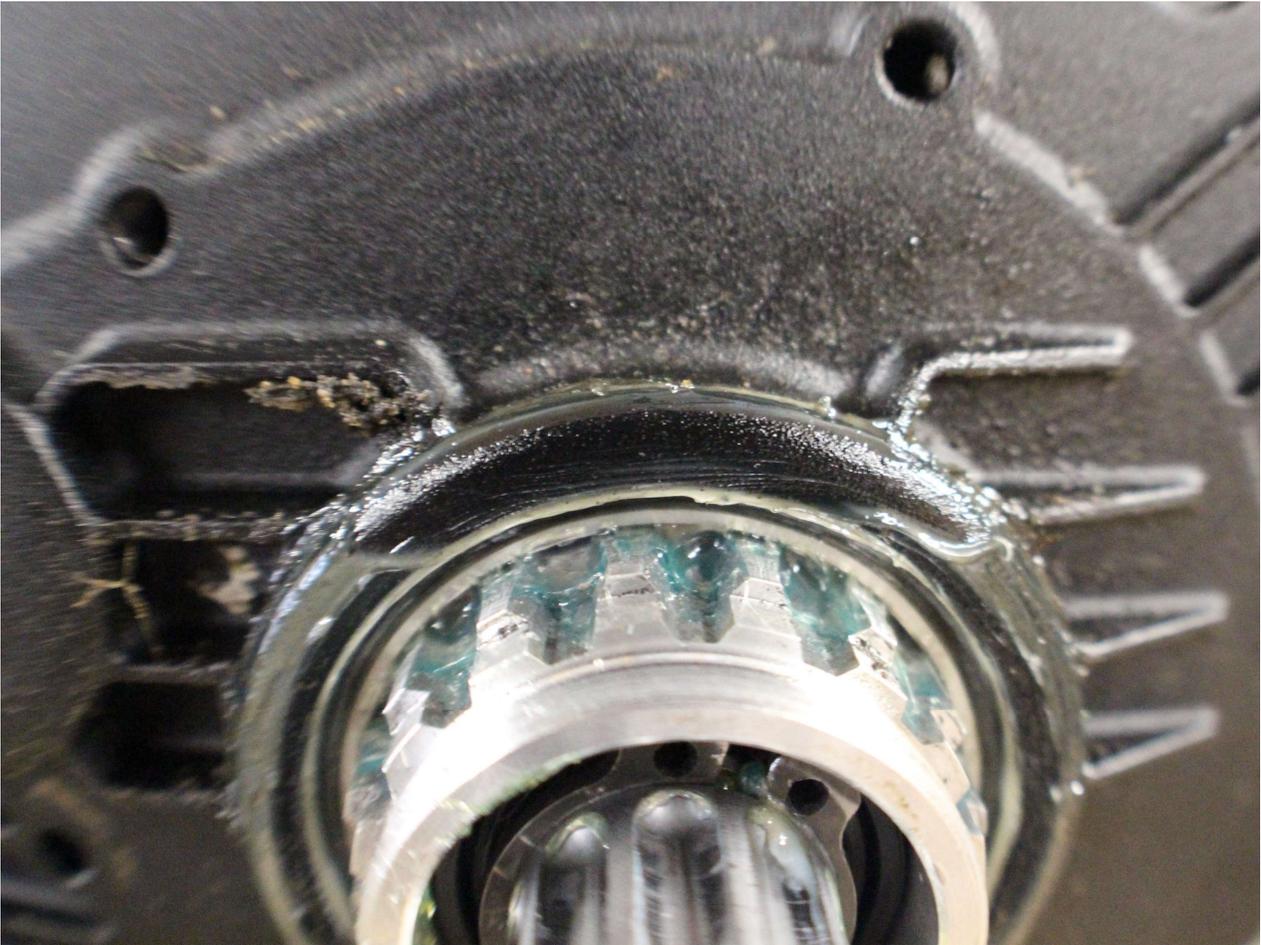
There was no wear or damage to the motor cover or the bearing.

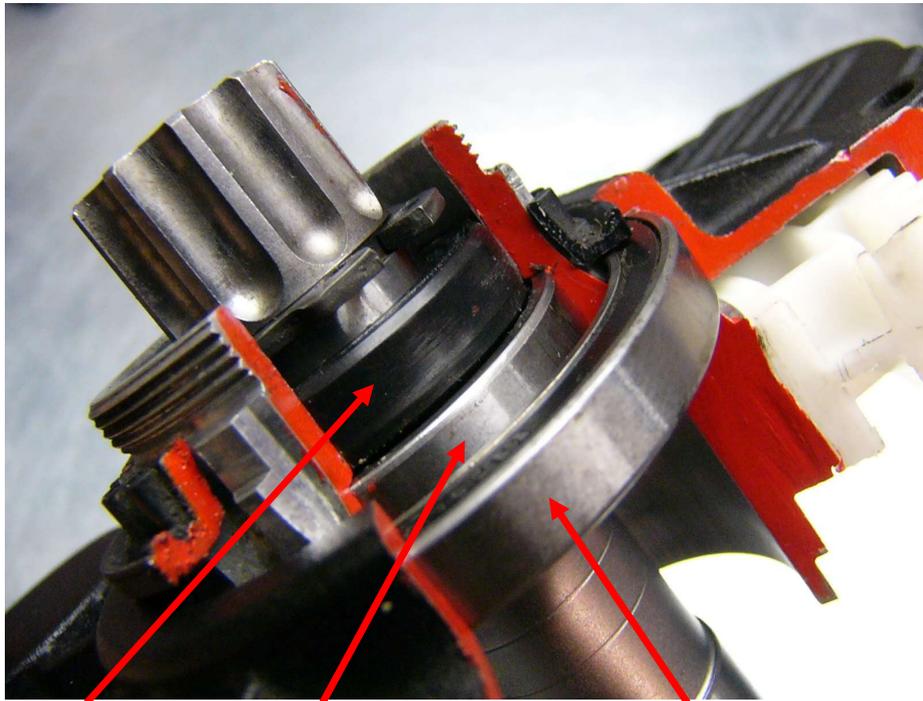
When the MudStop is fitted in conjunction with our double lip rotary seal, the right side of the motor is as protected as it can currently be.

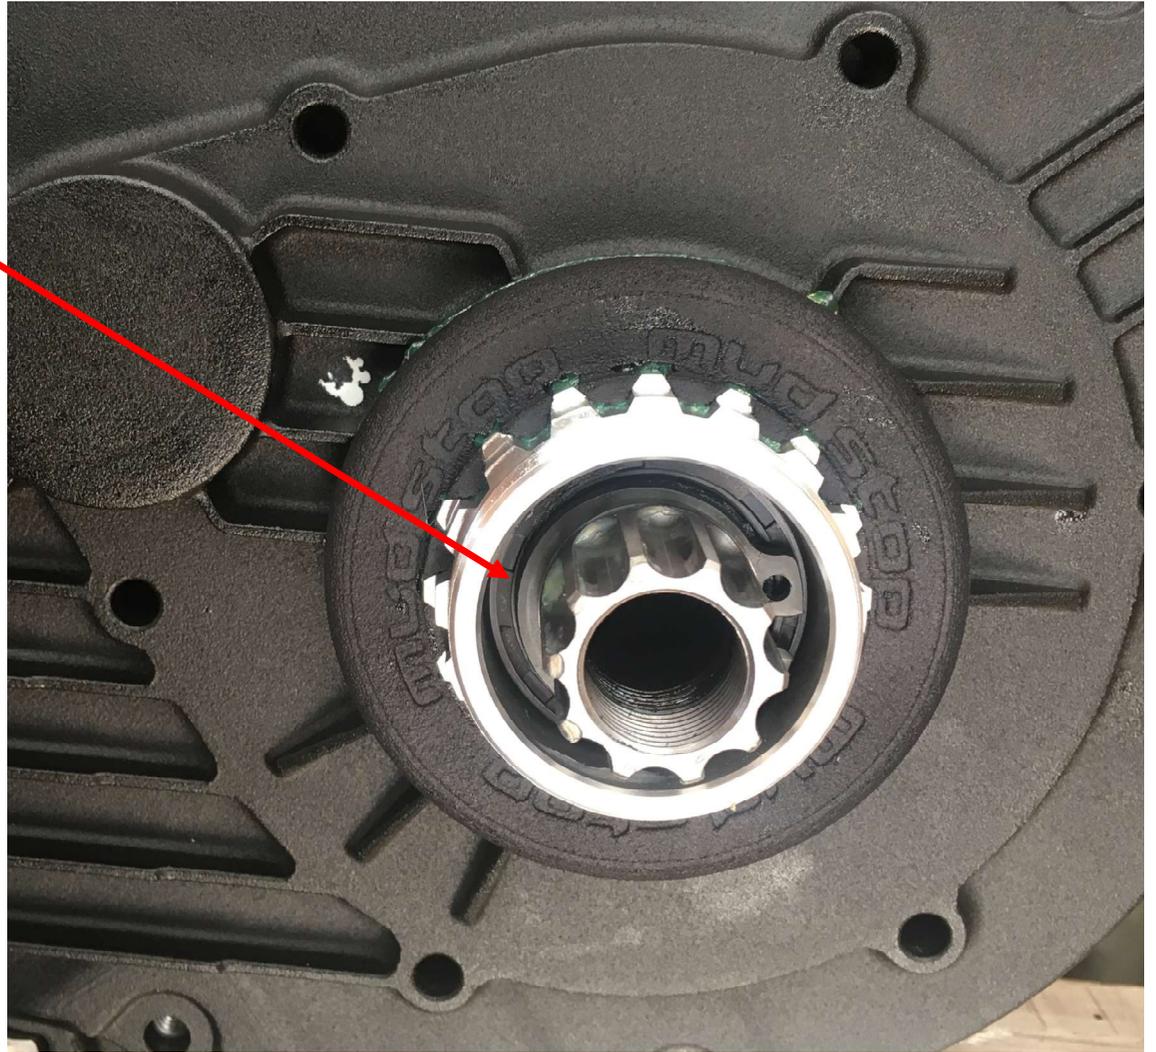
Seal Crankshaft bearing Main motor bearing

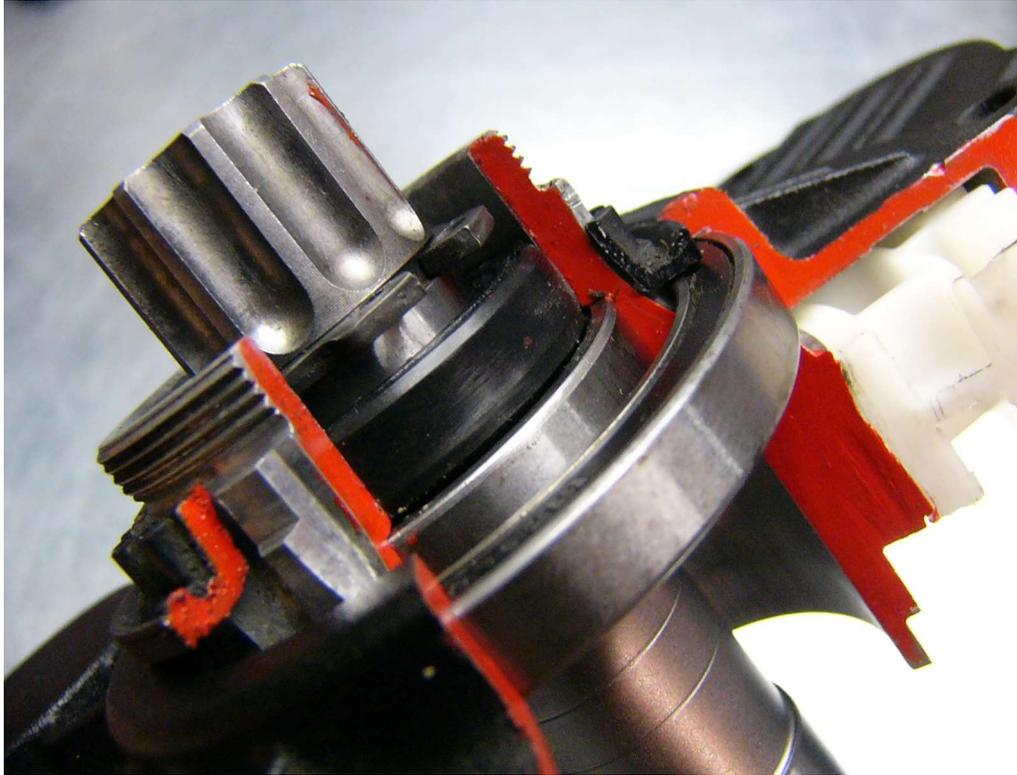
Sectional view MudStop

- a1: Deflector
- a2: Recovery gutter
- a3: Bearing joint covering
- b1: Motor bearing
- b2: Motor bearing joint
- c1: Output shaft
- d1: Engine crankcase
